Notes on a Recent Study  
OF THE  
Atlantic City Steel Paint Tests

# NOTES ON A RECENT STUDY OF THE ATLANTIC CITY STEEL PAINT TESTS

By HENRY A. GARDNER,

A recent inspection of the painted steel test panels\* erected by the Paint Manufacturers' Association at Atlantic City during October, 1908, has disclosed some startling changes in the weathering of the various paints as compared to their condition a year ago. These tests, which include a great number of oil paints, are affording most important information as to the comparative value of various pigments, when ground in linseed oil, as protective coatings for ferrous metals. Several of the paints have given excellent results, while others have completely failed to serve their intended purpose. The original contention upon which the tests were based, that pigments of the rust inhibitive and inert types, such as the slightly soluble chromates, the basic compounds, and the metallic oxides, would prove superior to those pigments of the tentatively termed rust stimulative class, which induce electrolysis either through the effect of

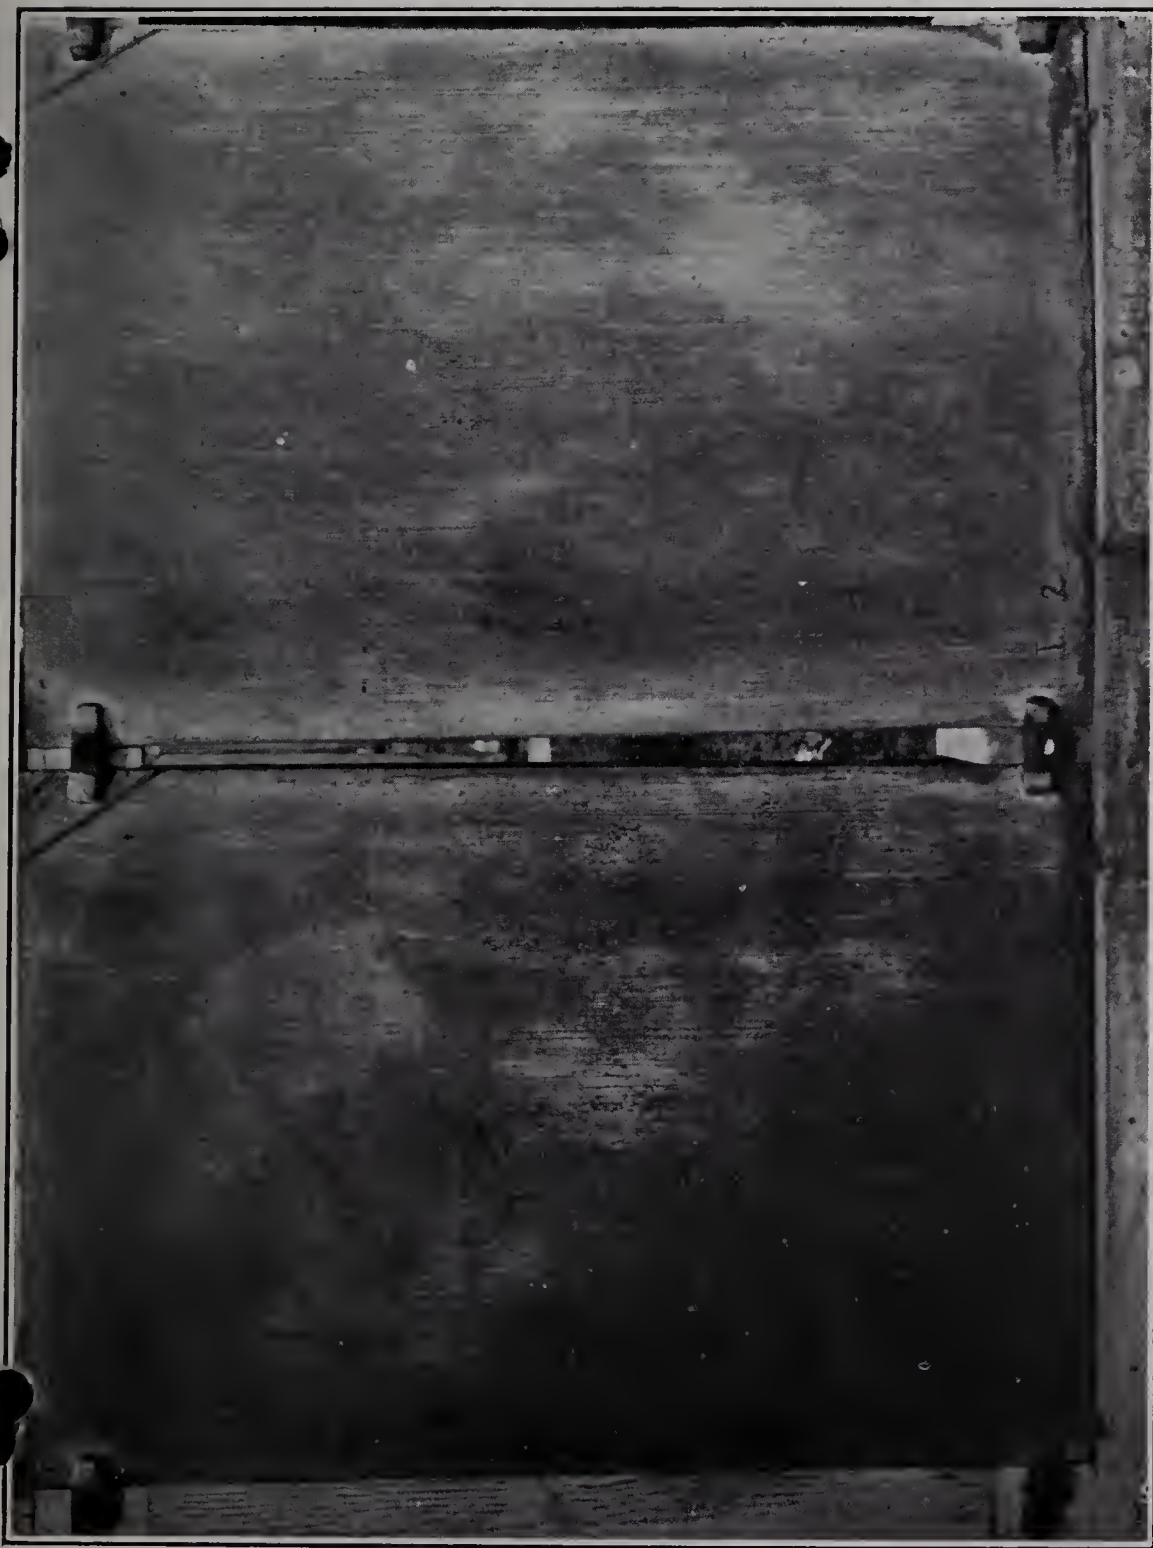
Panel No. 1, painted with Old Dutch Process White Lead (Basic Carbonate-White Lead), and Panel No. 2, painted with Quick Process White Lead (Basic Carbonate-White Lead), are both in very poor condition, their surfaces being covered with rust streaks which appear wherever brush marks were shown at the initial painting. Early in the test these panels developed considerable chalking, which was progressively washed off to such an extent that in the summer of 1911

a very thin coating was left. This coating during the past year has failed in a great many places, scaling and marked signs of disintegration having appeared.

<i>Panel No. 1</i>	<i>Detail</i>	<i>Panel No. 2</i>
Corroded White Lead (Basic Carbonate-White Lead), Old Dutch Process	April, 1912	Corroded White Lead (Basic Carbonate-White Lead), Quick Process
(Note how the heavy rust streaks follow the brush marks.)

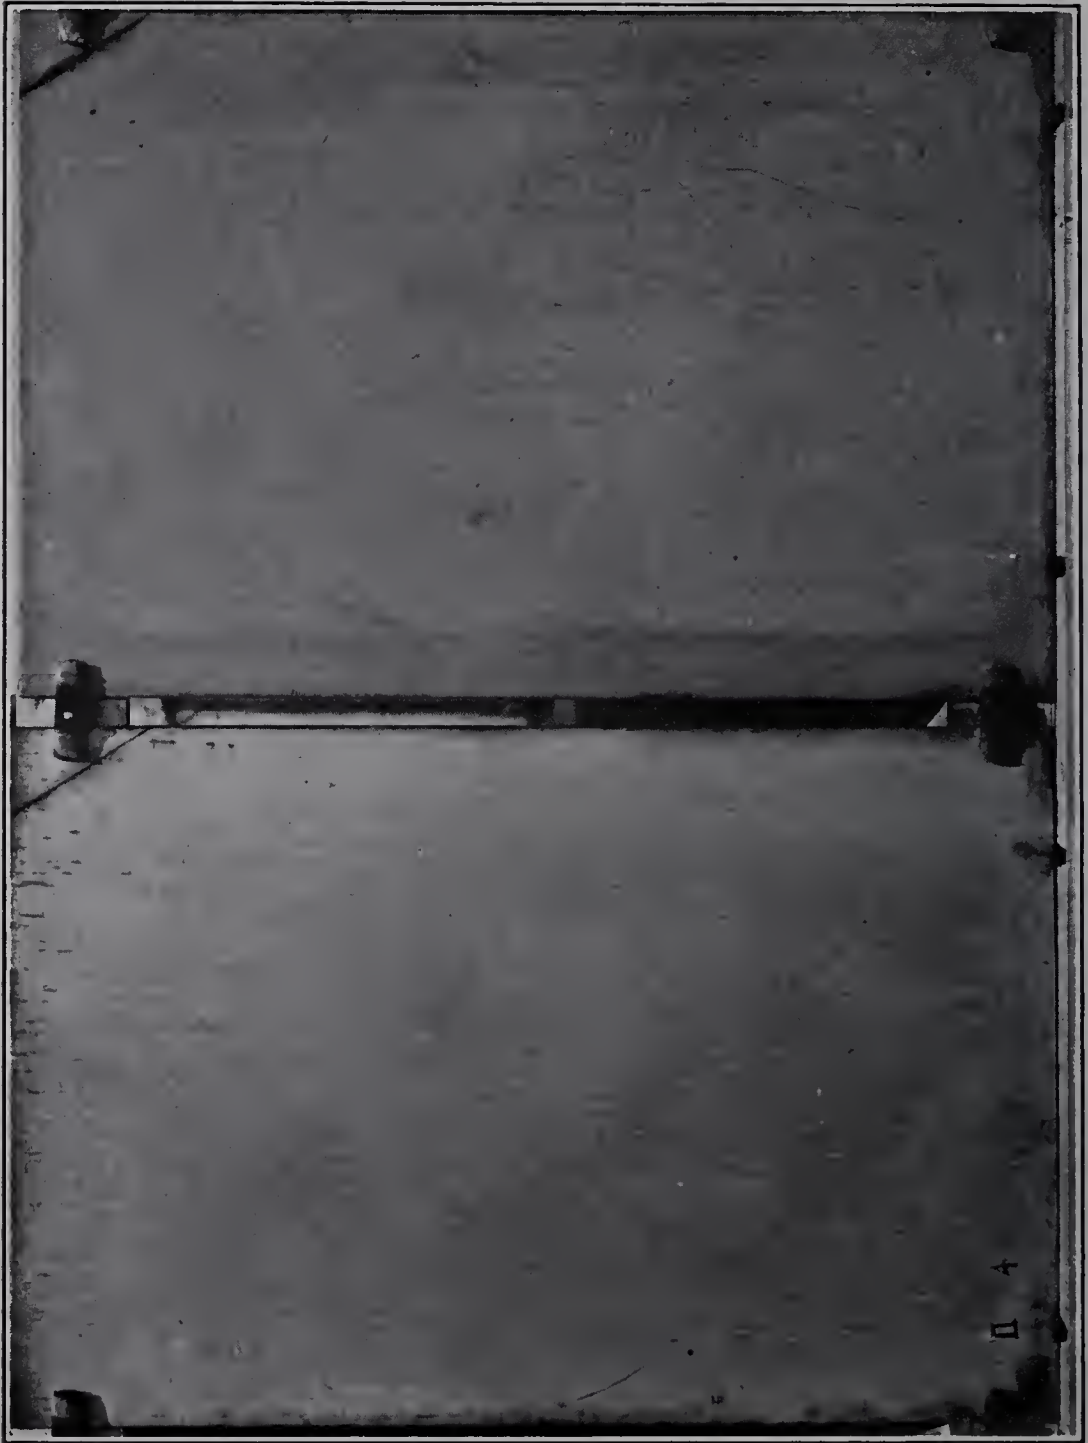
Panel No. 4, painted with Basic Sulphate-White Lead, and Panel No. 5, painted with Sublimed Blue Lead, are both in excellent condition. Although considerable chalking was shown on each of these panels, the paint films are intact and of a tough, elastic nature, presenting to the touch a velvety feeling. The Sublimed Blue Lead was somewhat superior to the Basic Sulphate-White Lead, although the latter showed better color maintenance.

*Panel No. 4*

Sublimed White Lead (Basic Sulphate-White Lead)

(Good condition of these basic pigments is shown by photograph.)

*Panel No. 5*

Sublimed Blue Lead

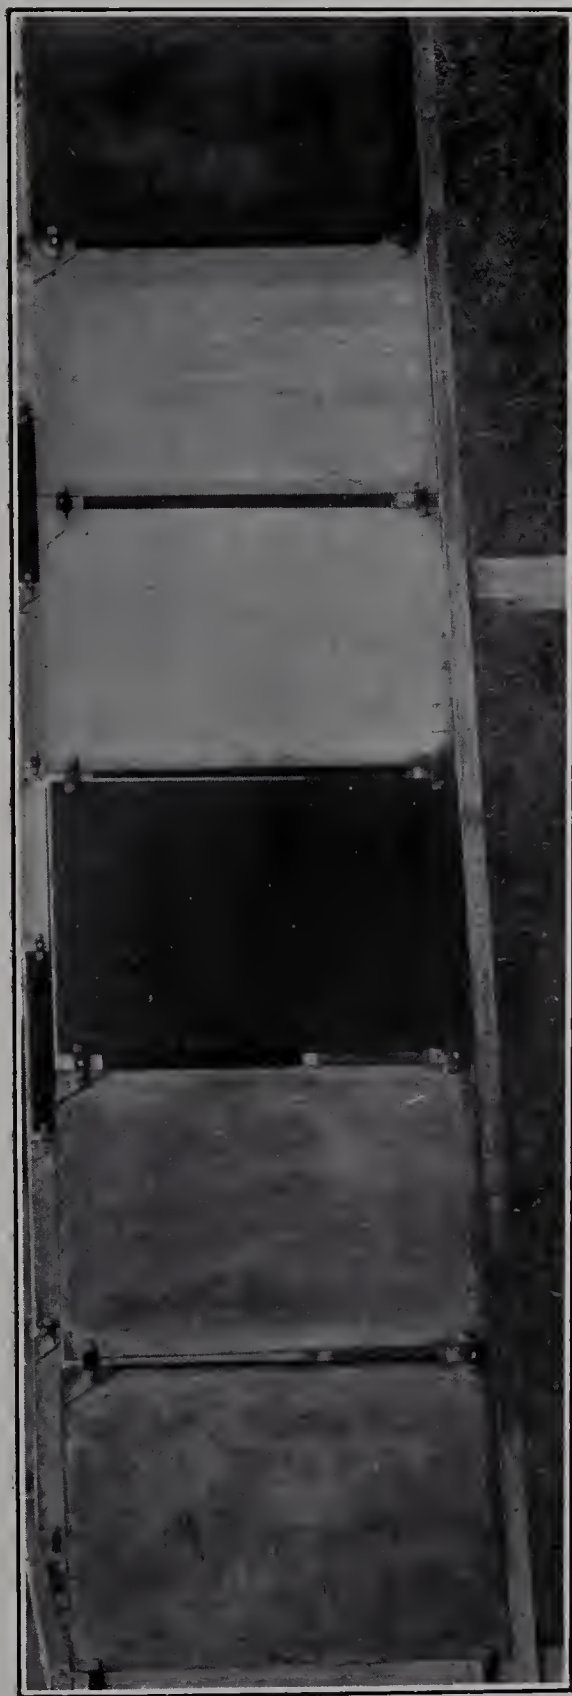
Group, April, 1912

Panel No. 3, painted with Zinc Oxide, indicated at the beginning of the test that the paint used was too stiff and thus lacking in elasticity; Zinc Oxide being a pigment which demands a considerable quantity of oil. The rust lines on the paint, where the brush marks were left, are heavy. What remains of the paint, however, is very hard, and beneath the surface the steel is clean, indicating that the pigment itself is of an inhibitive nature.

Panel No. 6, painted with Lithopone, indicated at the beginning of the test that this pigment when used alone was unfit for the protection of iron and steel exposed to the weather. The panel at the present time is covered with rust beneath the surface of the film, and in some places the rust has broken through and disrupted the coating. The

<i>Panel No. 1</i>	<i>Panel No. 2</i>	<i>Panel No. 3</i>	<i>Panel No. 4</i>	<i>Panel No. 5</i>	<i>Panel No. 6</i>
Dutch process corroded white lead (basic carbonate-white lead)	Quick process corroded white lead (basic carbonate-white lead)	Zinc Oxide	Sublimed white lead (basic sulphate-white lead)	Sublimed blue lead	Lithopone: 70 % barium sulphate, 30 % zinc sulphide

(View of some of the lead and zinc pigments.)

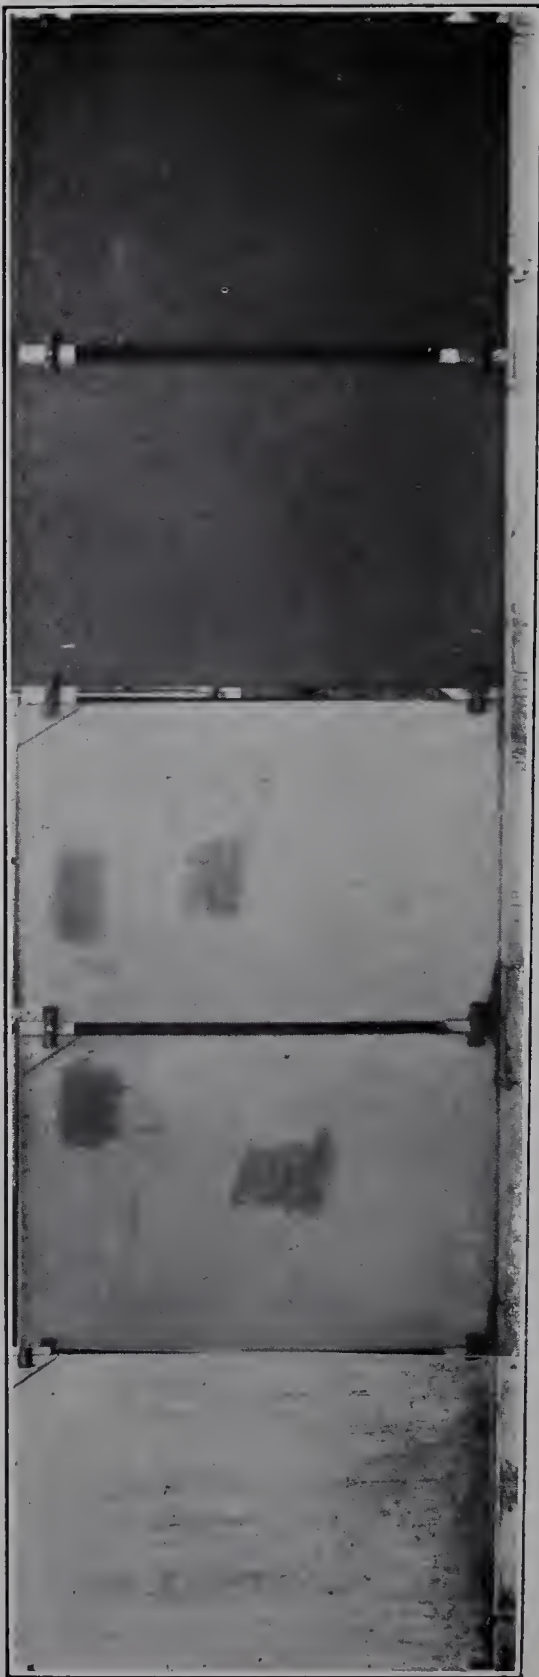
April, 1912

Panel No. 7, painted with Zinc Lead, is streaked with dark brown rust wherever the brush marks were formerly apparent.

At the beginning of the test Panel No. 9, painted with American Orange Mineral, and Panel No. 10, painted with Red Lead, gave excellent service. Until last year these panels were in perfect condition except for a whitening of the surface which is probably due to the formation of a coating of white carbonate of lead, effected by the carbonic acid of the atmosphere, giving to the panels a pinkish tint. On panel No. 9 there are several slight rust spots appearing through the surface of the paint. Panel No. 10 is slightly darker than Panel No. 9, and has offered greater resistance to the destructive effect of the salt air.

Panel No. 12, painted with Bright Red Oxide, and Panel No. 14, painted with Venetian Red, are both in generally good condition, with the exception of a few rusty brush streaks on Panel No. 12 and a few slight corrosion spots on Panel No. 14.

*Panel No. 7*  
Zinc lead  
50% zinc oxide  
50% lead sulphate

*Panel No. 9*  
Orange mineral  
(red lead)

*Panel No. 10*  
Red lead

*Panel No. 12*  
Bright red oxide of  
iron

*Panel No. 14*  
Venetian red (oxide of  
iron containing calci-  
um sulphate)

Marks on panels 9 and 10 were made at inspection by rubbing  
whitened surface. The red color of the red lead is shown where  
whitened surface was removed. (See report.)

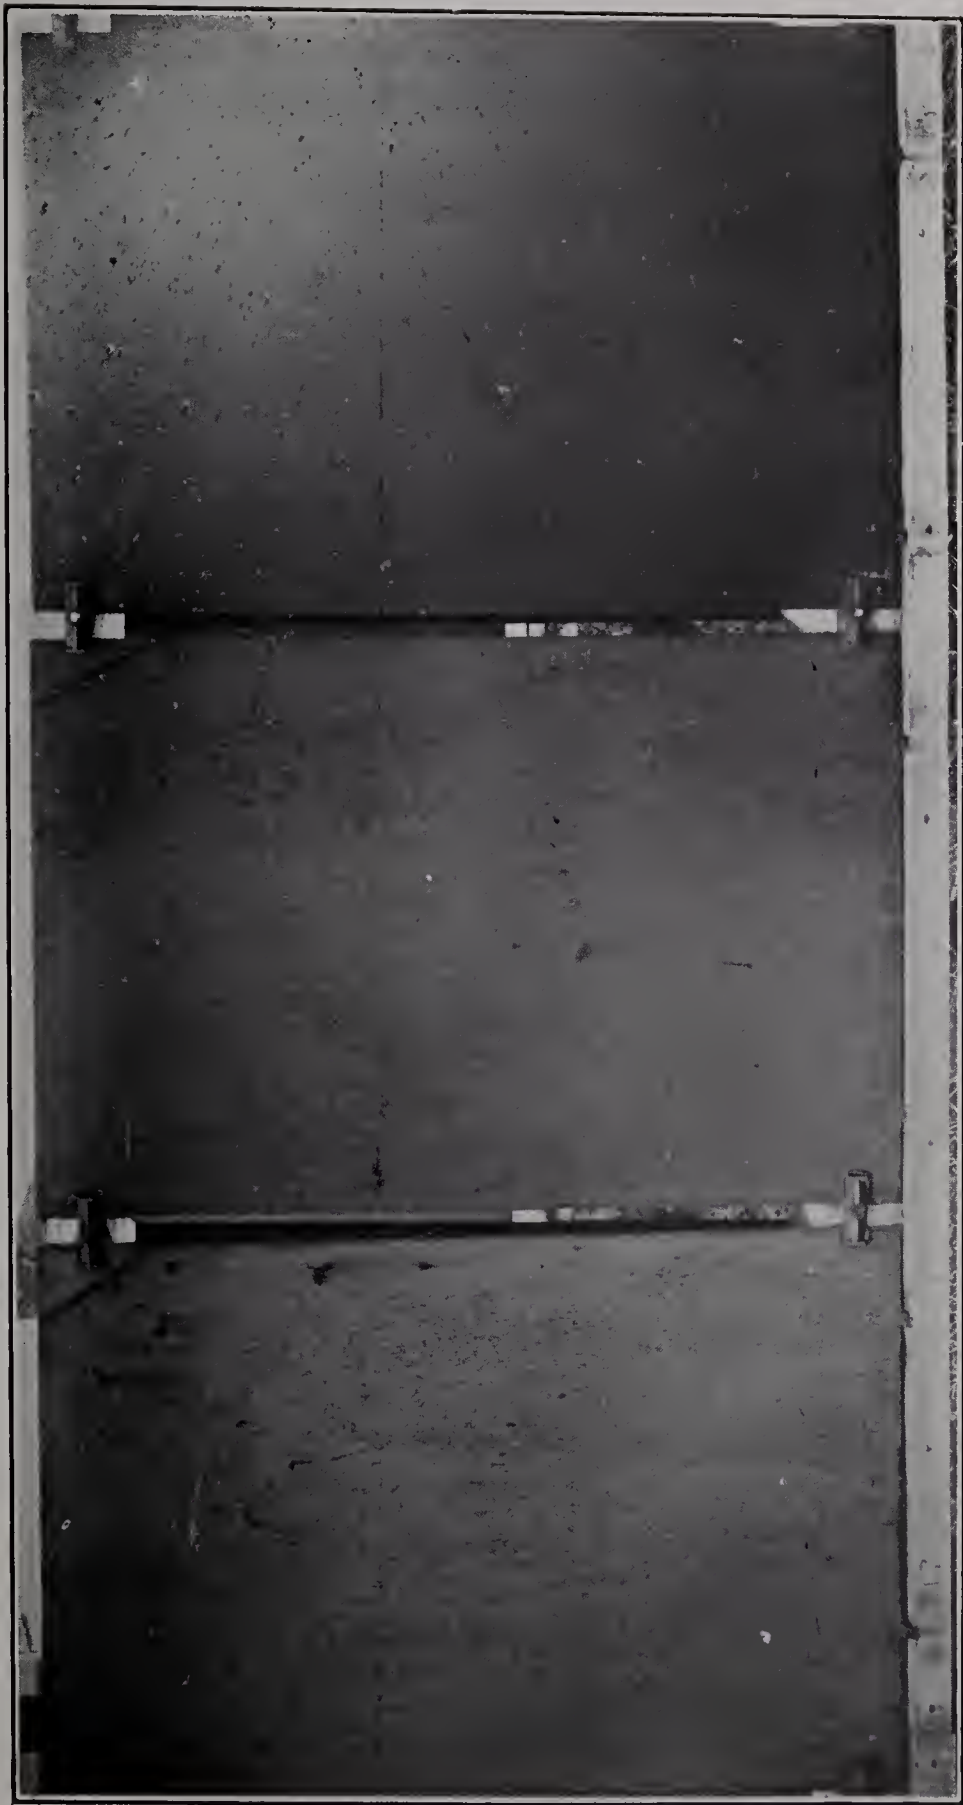
Panel No. 17, painted with Artificial Graphite, is uniformly covered with large rust spots, which are spreading over a wide area, and thousands of small pin-head eruptions. This panel is chalking heavily, the chalked surface resembling stove polish in appearance. The inferior condition of this panel as compared with Panel No. 16 (Natural Graphite) may be accounted for by the fact that Natural Graphite contains inert pigments such as silica and iron oxide.

Panel No. 19, painted with Lampblack and Barytes, is covered with small round pin-head eruptions which have not yet broken through. It also has a spotted and dull appearance and shows considerable chalking.

Panel No. 20, painted with Willow Charcoal, is the best appearing black of carbonaceous origin upon the fence. It has a deep color and is showing no corrosion nor chalking.

*Panel No. 17*  
Artificial Graphite

April, 1912  
*Panel No. 19*  
Lampblack and Barytes

*Panel No. 20*  
Willow Charcoal

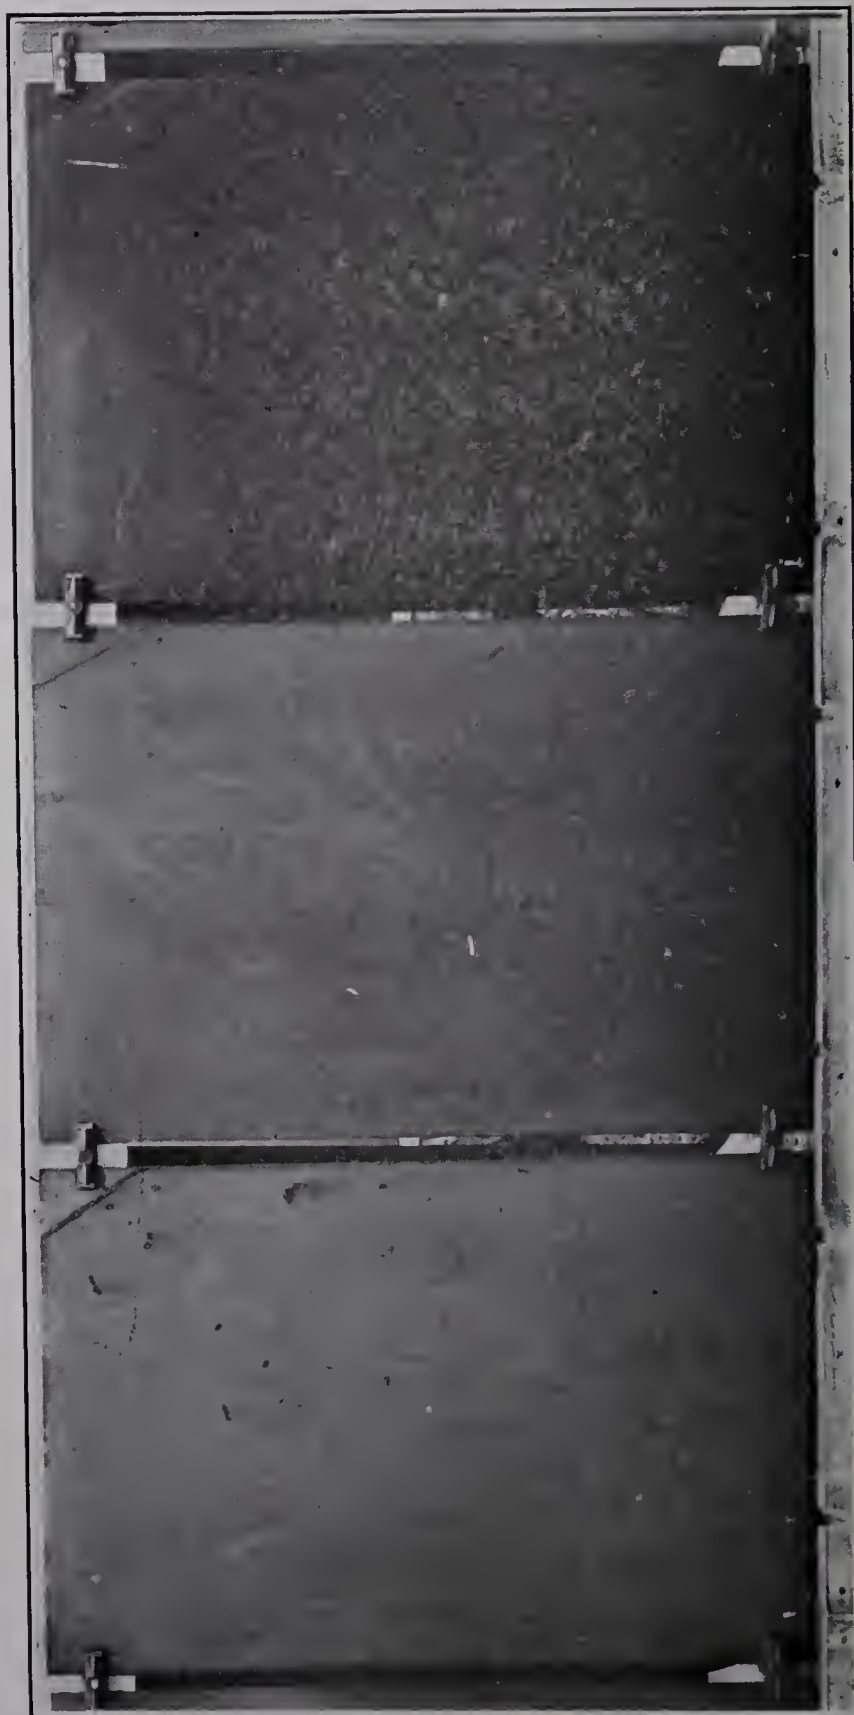
June, 1910

*Panel No. 17*  
Artificial Graphite

*Panel No. 19*  
Lampblack and Barytes

*Panel No. 20*  
Willow Charcoal

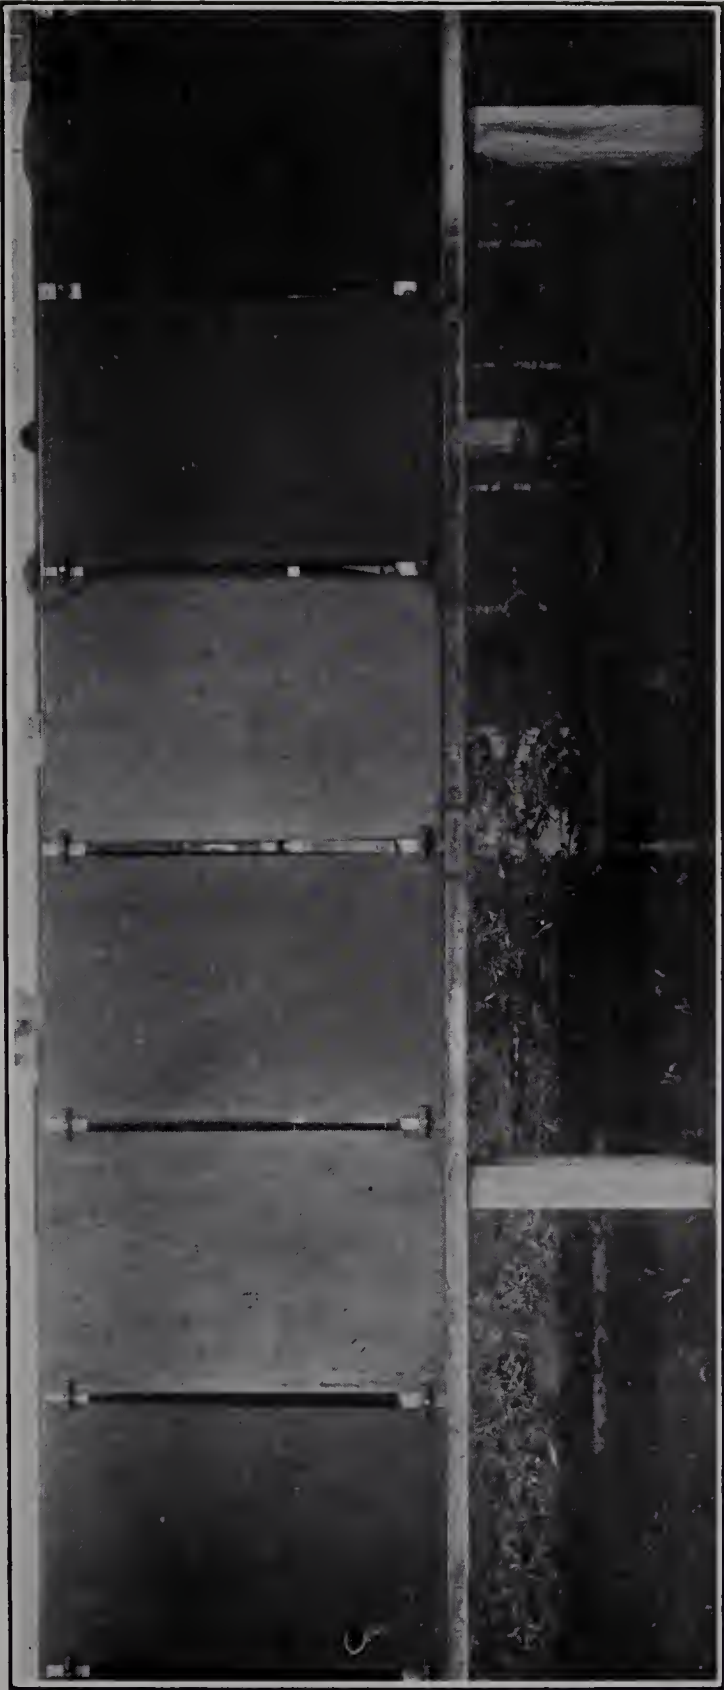
April, 1912

Panel No. 34, painted with American Vermilion (Basic Chromate of Lead), is in perfect condition.

Panel No. 36, painted with Lead Chromate, is streaked around the edges for a distance of six

inches with thin lateral and horizontal streaks of rust. The middle of the panel, however, is in good condition.

Panel No. 39, painted with Zinc Chromate, is in excellent condition.

Panel No. 40, painted with Zinc-and-Barium Chromate, has developed a slight greenish tint and a little chalking. Otherwise this panel is in excellent condition.

Panel No. 41, painted with Pure Chrome Green, is in perfect condition except for the development of a slight bluish tint along the edges.

Panels Nos. 44 and 45, painted with Prussian Blue, are both in good condition. While Panel No. 44 has developed a slight greenish tint, Panel No. 45 is still evidencing a most brilliant maintenance of its dark blue color and gloss.

<i>Panel No. 34</i>	<i>Panel No. 36</i>	<i>Panel No. 39</i>	<i>Panel No. 40</i>	<i>Panel No. 41</i>	<i>Panel No. 44</i>
American vermilion (basic chromate of lead)	Lead chromate	Zinc chromate	Zinc-and-barium chromate	Chrome green	Prussian blue

(Note excellent condition of rust-inhibitive pigment paints.)

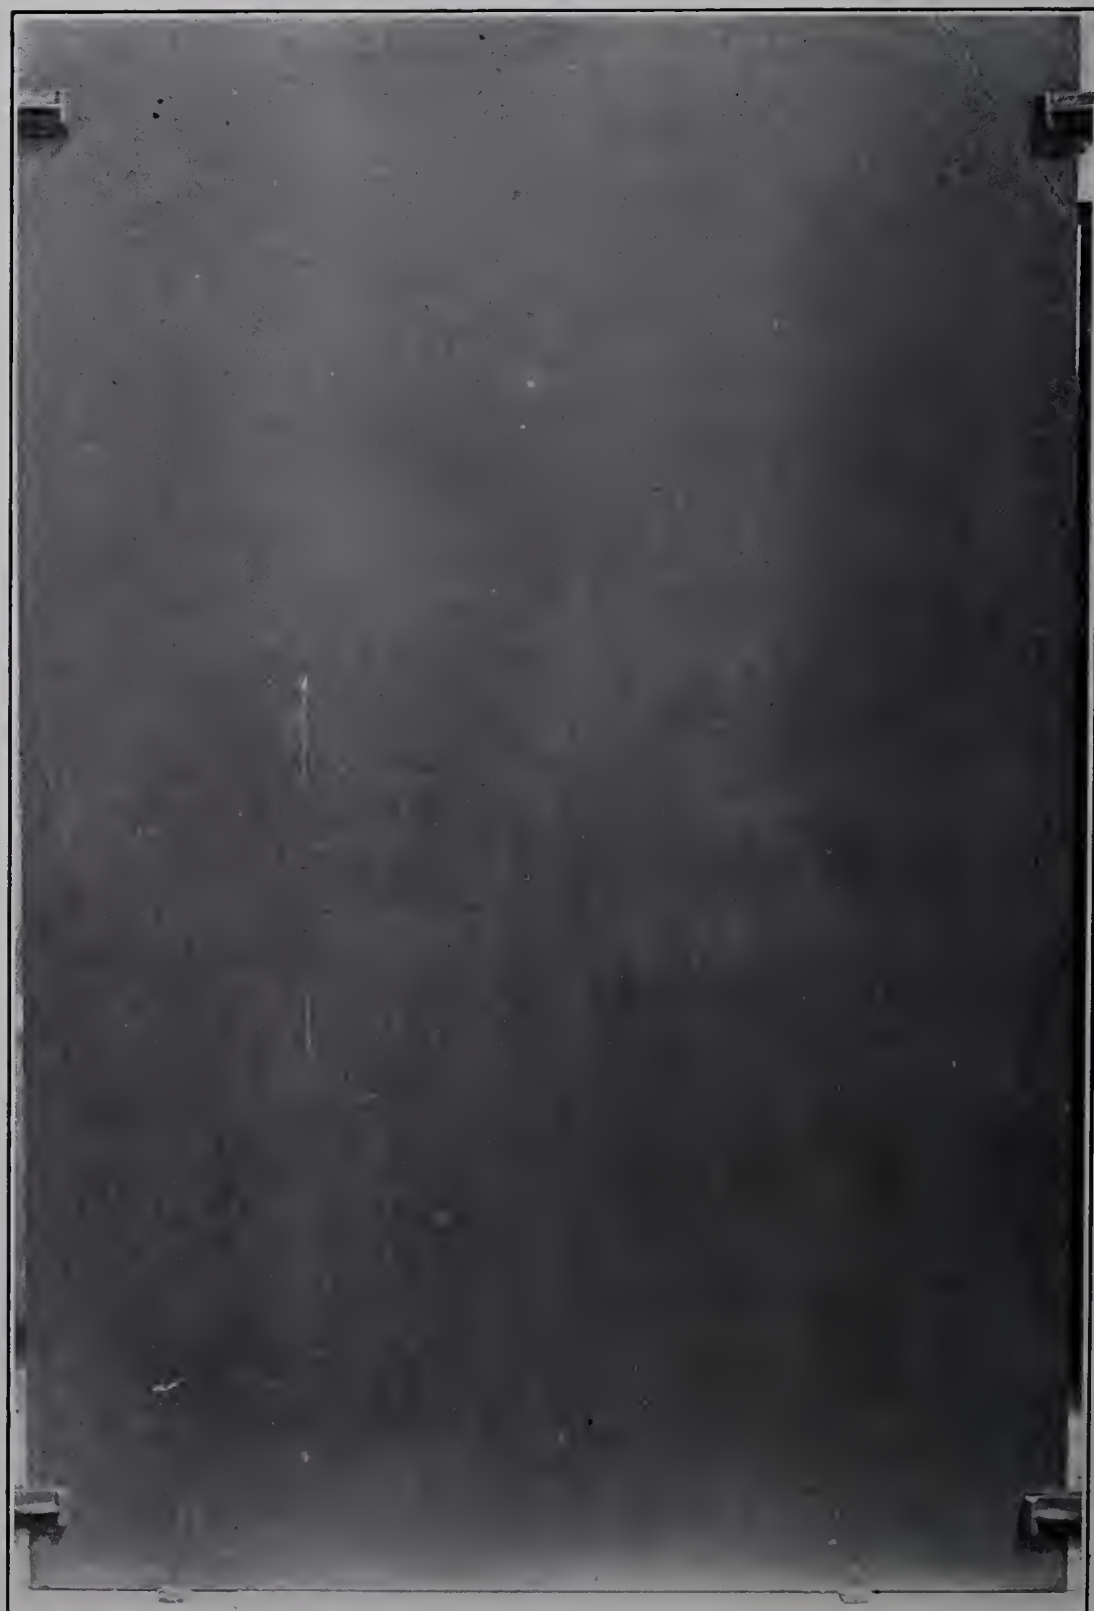
June, 1910

American Vermilion (Basic Chromate of Lead)

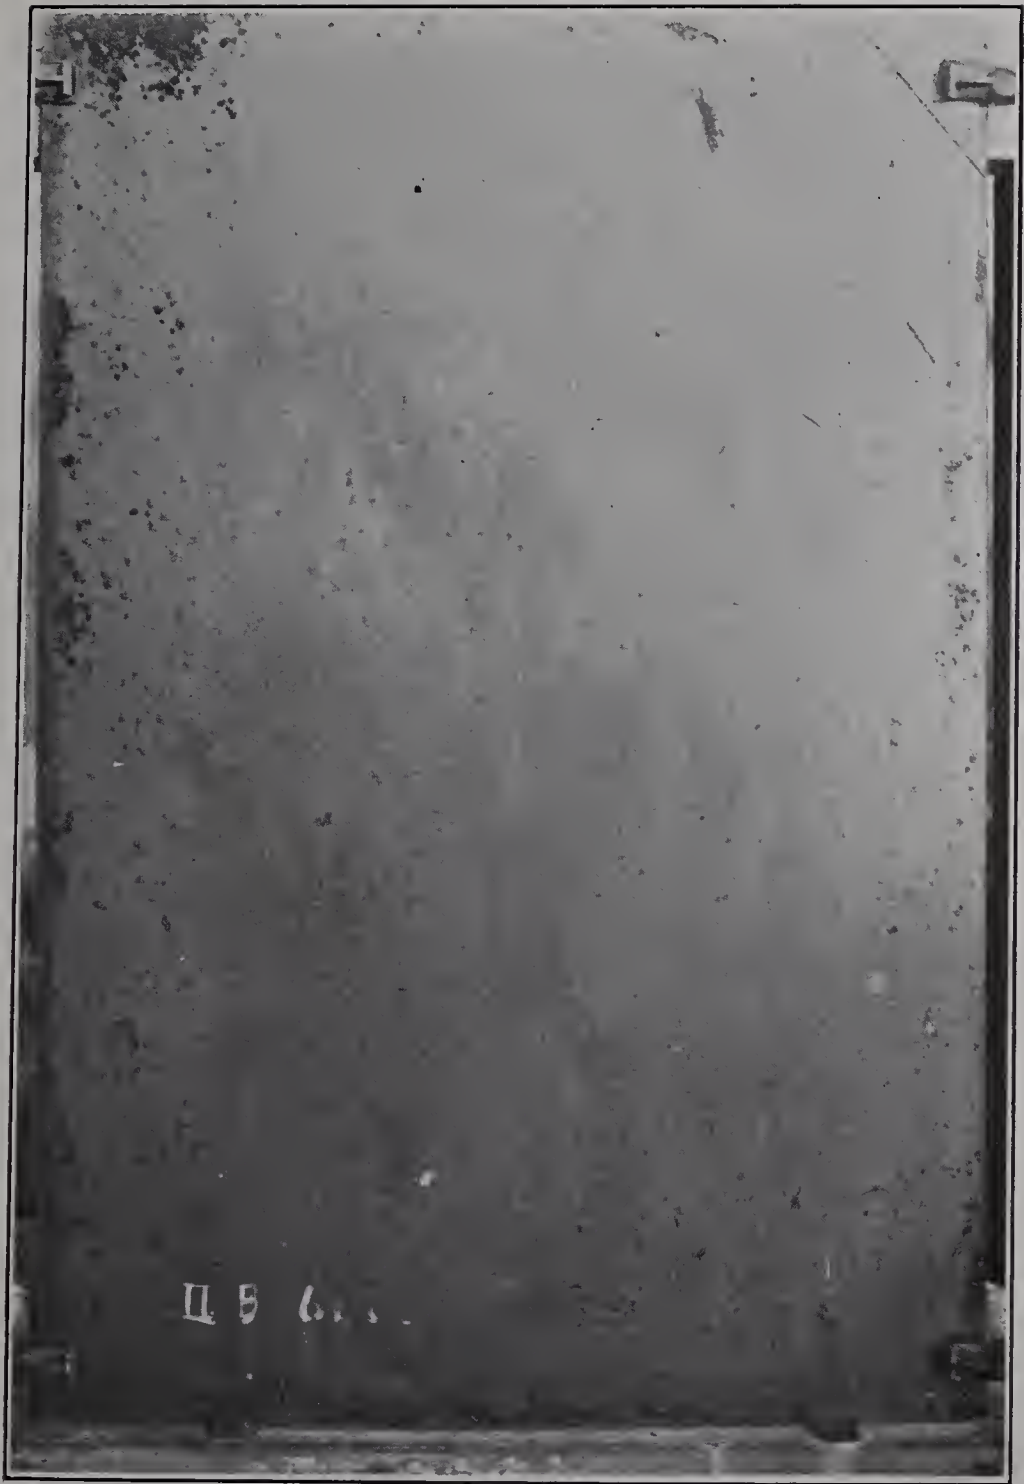
*Panel 6666*

Corrosion pits on panel painted with stimulative pigment
